Thanks for the time to meet last week to review the waterway at Harrison Rd for navigability and possible permitting requirements. I'm outlining below the facts that we know about the location/project followed by some items to consider for "next steps" forward.

Navigability Determination

Docket #:
INF-NE-2015-8-02636

Waterway Name (If applicable):
unnamed tributary to Lake Winnebago

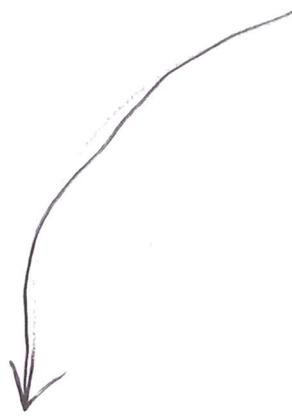
Channel
~ 10-12" wide @ TOB / OHWM (narrower bed width)
~ 9-12" + deep channel
~ 3" running water (sandy/cobbly bed material)
OHWM @ ~ 4" ~~deep~~ high off bed
Full of Jewelweed!!

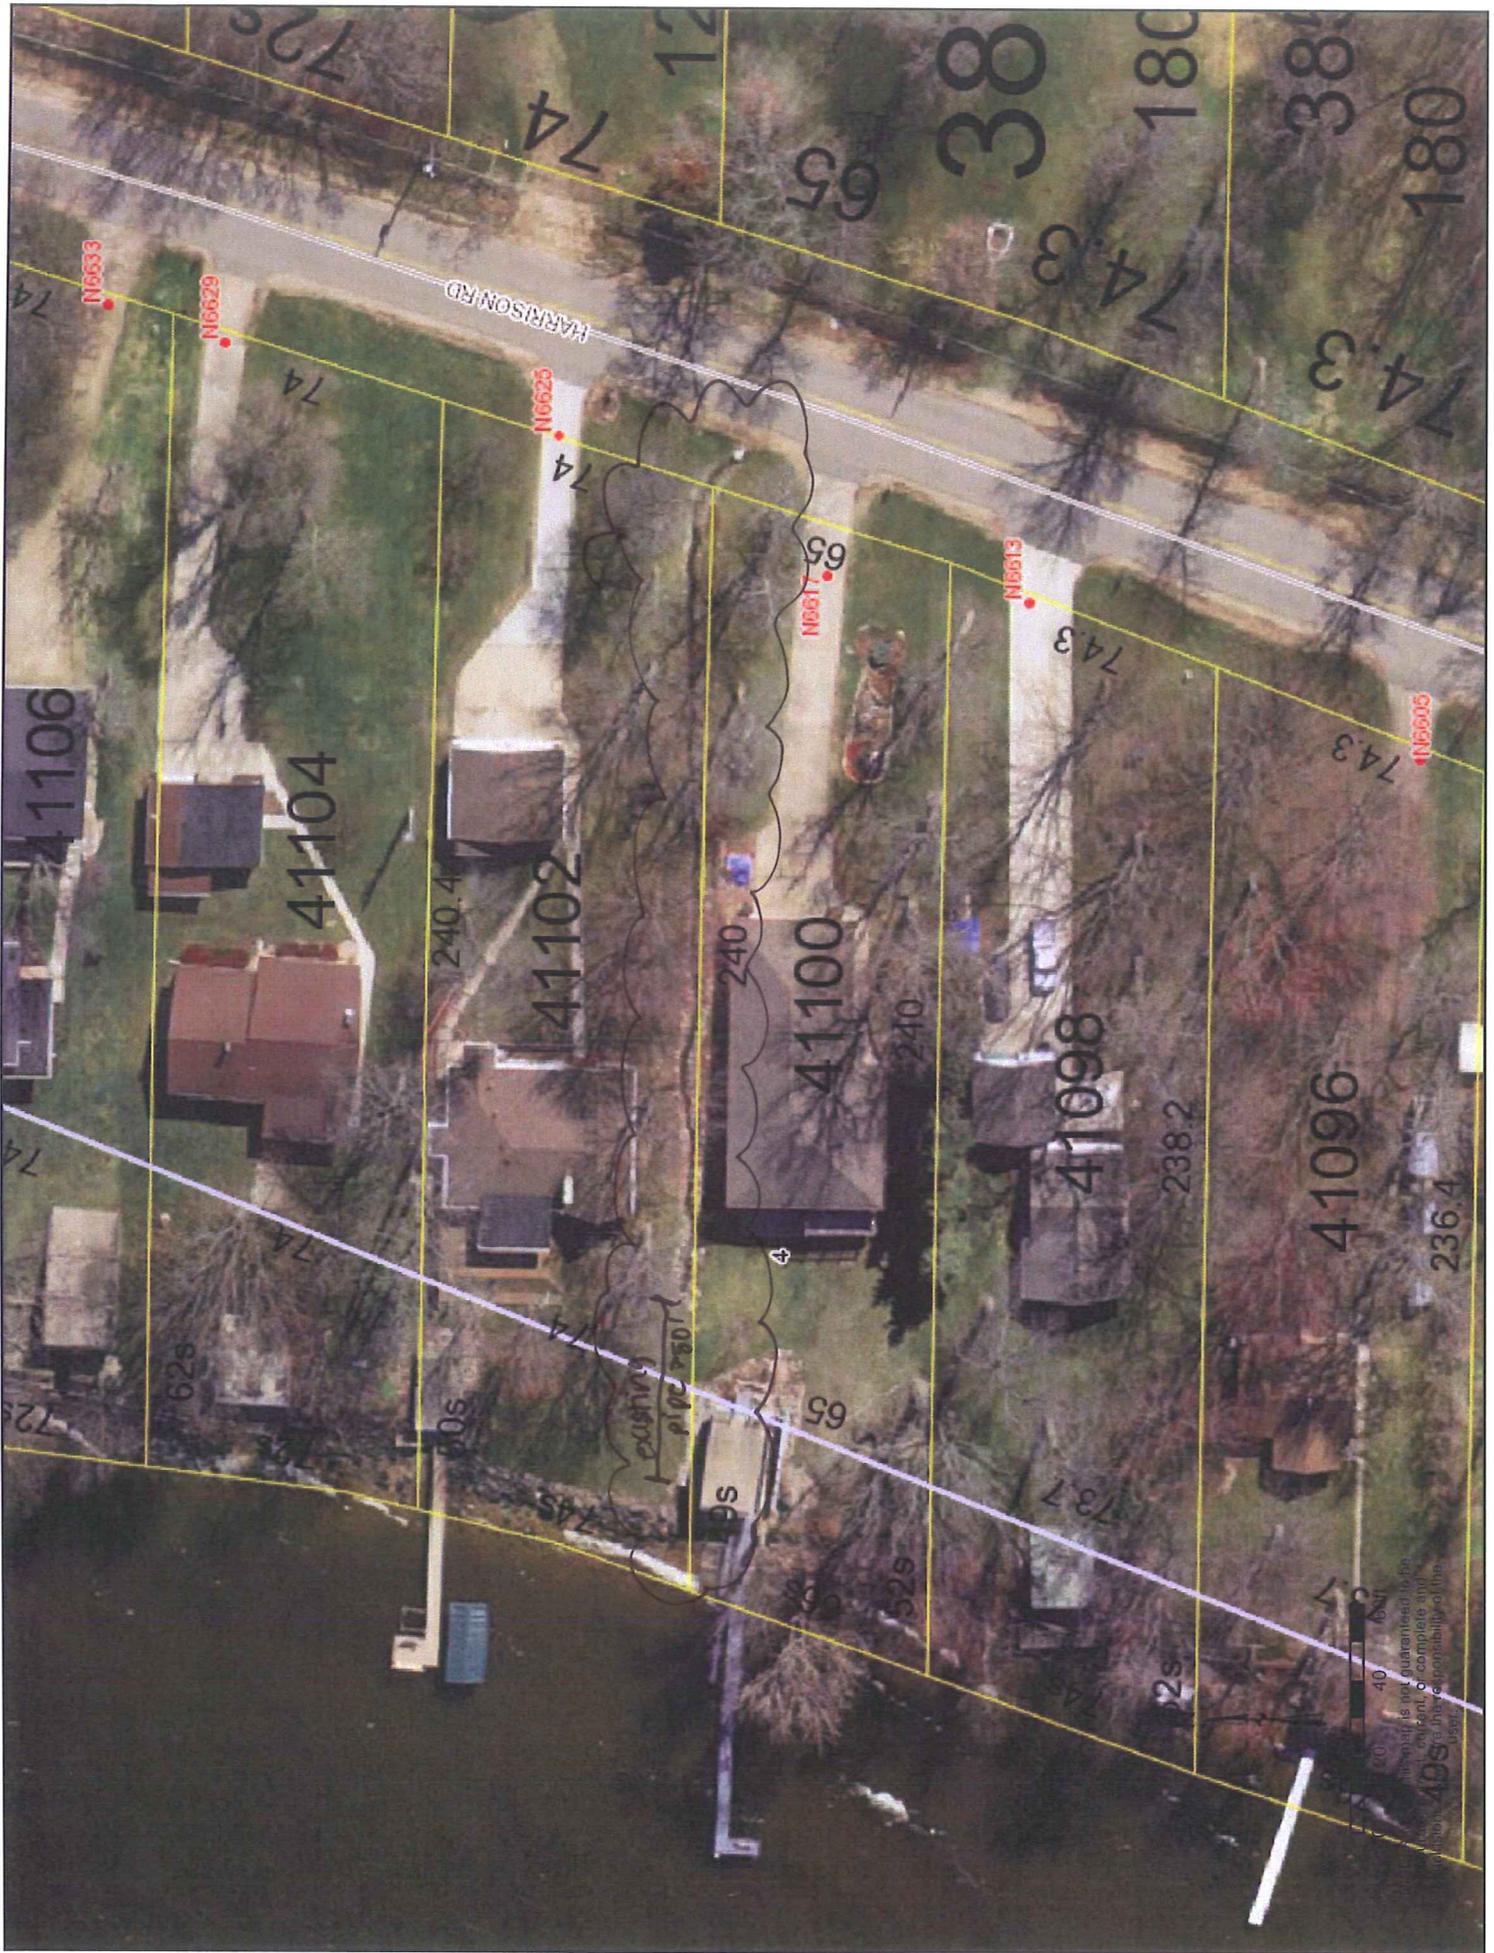
HARRISON RD

Leaking pipe 201
